NDE OF BLACK HAWK HELICOPTER ROTARY WING-HEAD SPINDLE
THREADS USING ELECTRIC CURRENT PERTURBATION

Final Report
SwRI Project 15-7958-818

U. S. Army Aviation Research and
Development Command
St. Louis, Missouri

November 1985

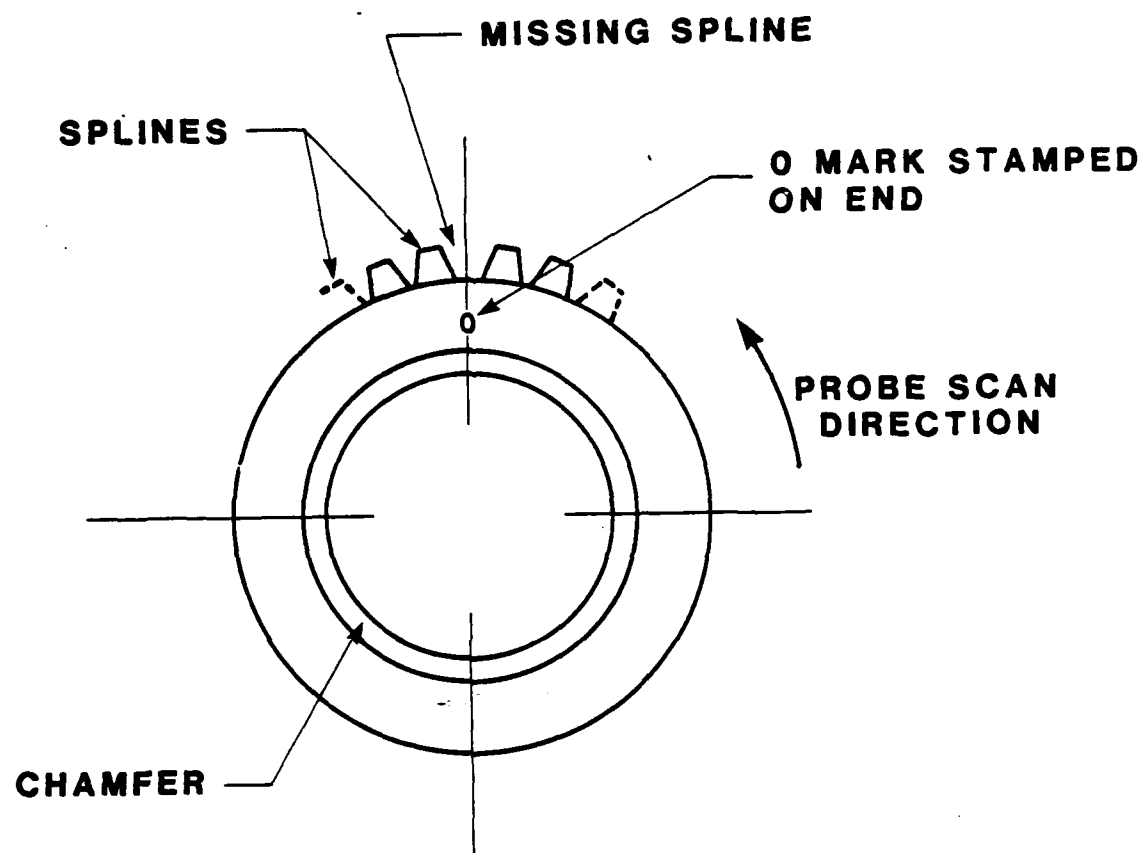
FIGURE 1. ECP PROBE SCAN DIRECTION LOOKING INTO
THREADED END OF SPINDLE

A laboratory setup was established which allowed the spindles to be simultaneously rotated and translated axially by means of a motor drive and lead screw arrangement. The ECP probe remained stationary and the relative motion between the probe and spindle provided a helical scan so that the probe maintained a fixed relationship with respect to the threads. This arrangement minimized influence of the thread geometry on the overall signal response. The probe rode on an air bearing to eliminate contact with the thread surface. Two air bearing blocks were matched to the respective -102 and -103 spindle threads. The probe scan direction with respect to the spindle is shown in Figure 1. The "missing spline" as shown in the figure is typically used as a reference position. Rotational speed was 5.26 rpm.
